1050799

**U.S. Environmental Protection Agency  
Vasquez Boulevard I/70 Superfund Site  
Replacement Certificate**

## LBP Assessment Results

Property ID # 3413 / 3846 Gilpin Street

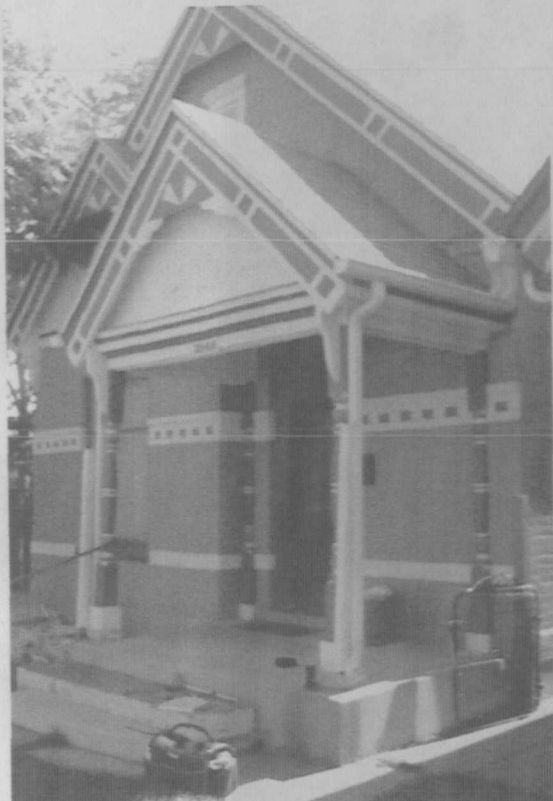
West exposure of house

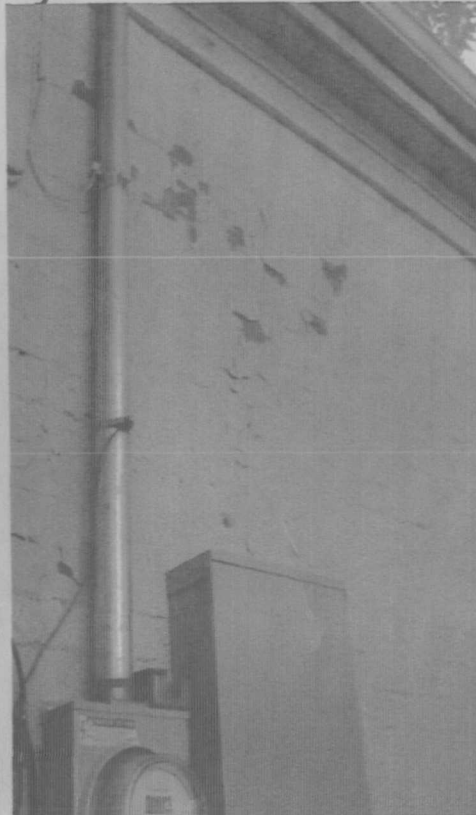
North exposure of house containing peeling lead paint

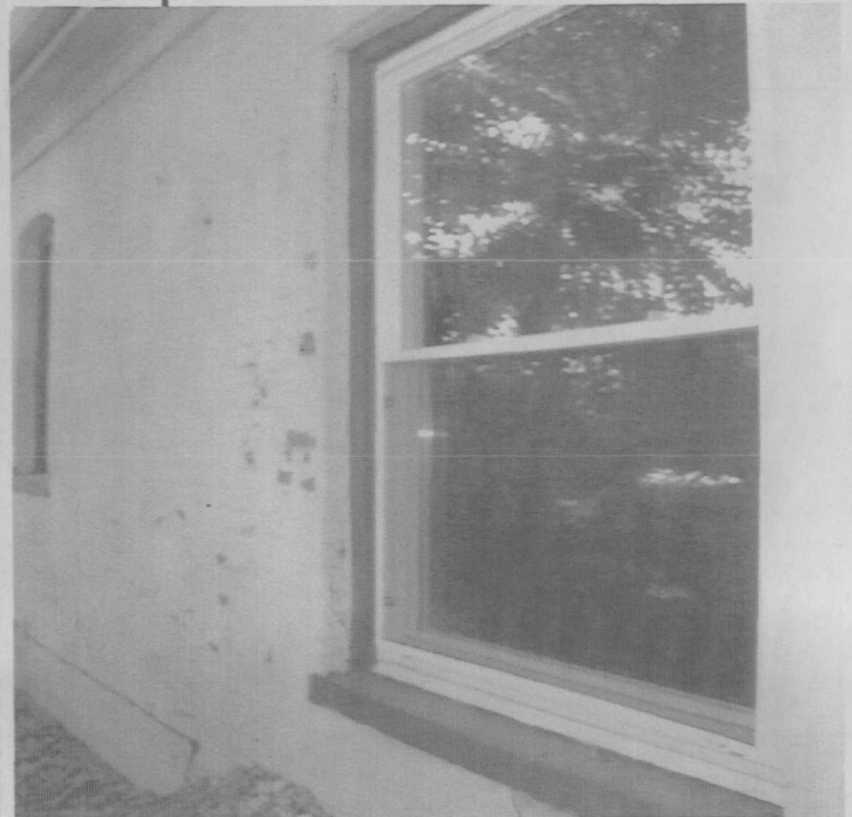
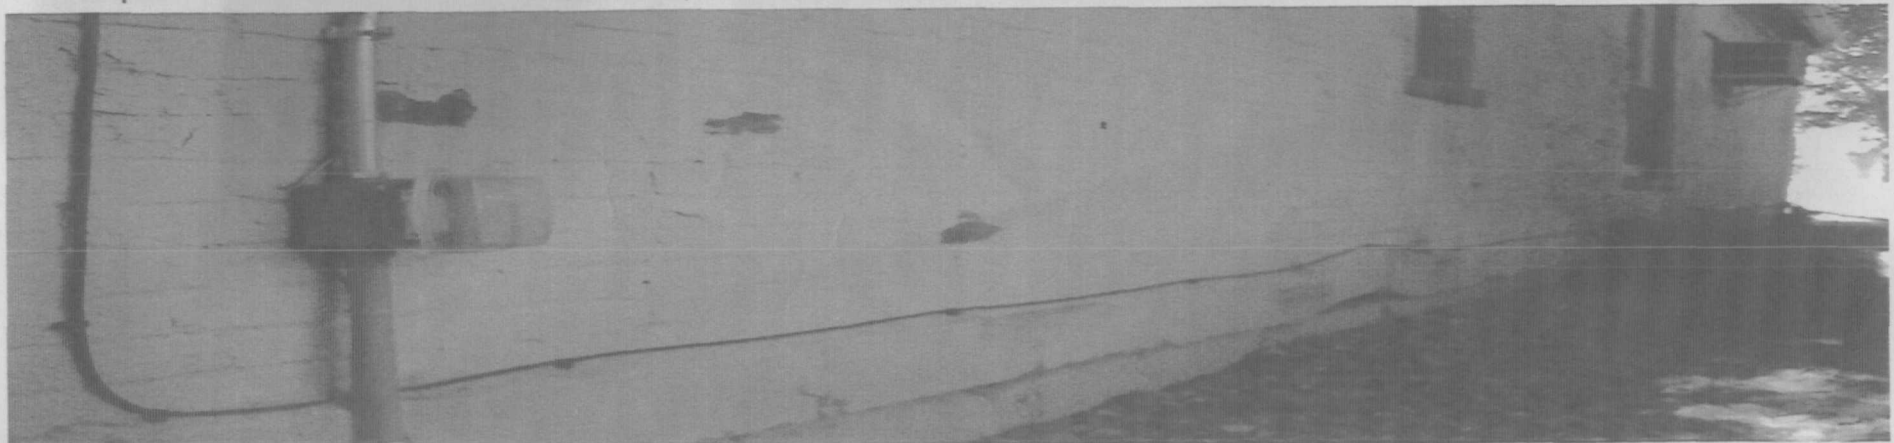
North exposure of house showing signs of peeling paint

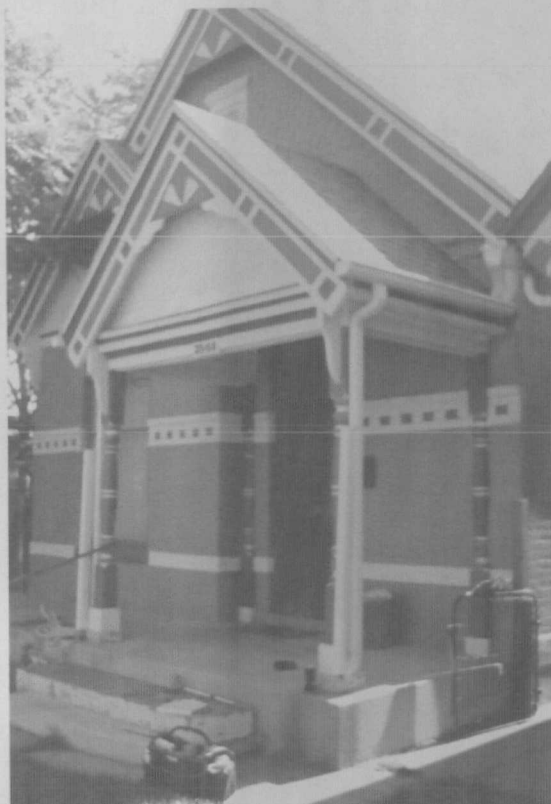
West exposure of house

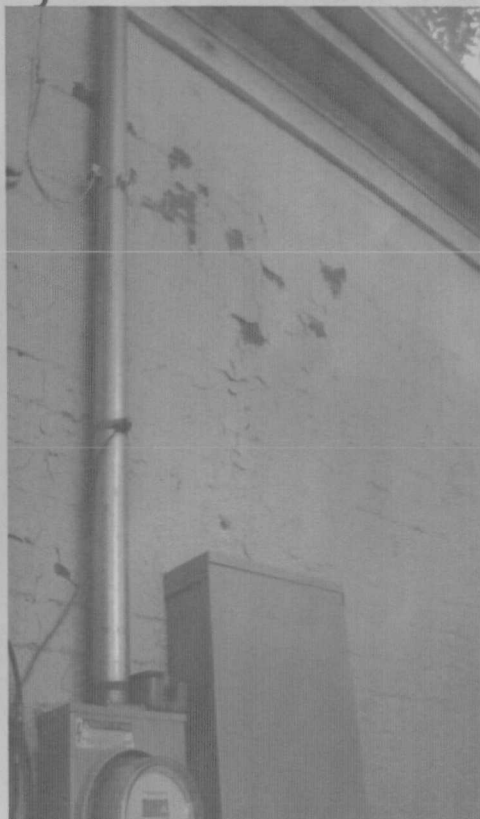
North exposure of house containing peeling lead paint

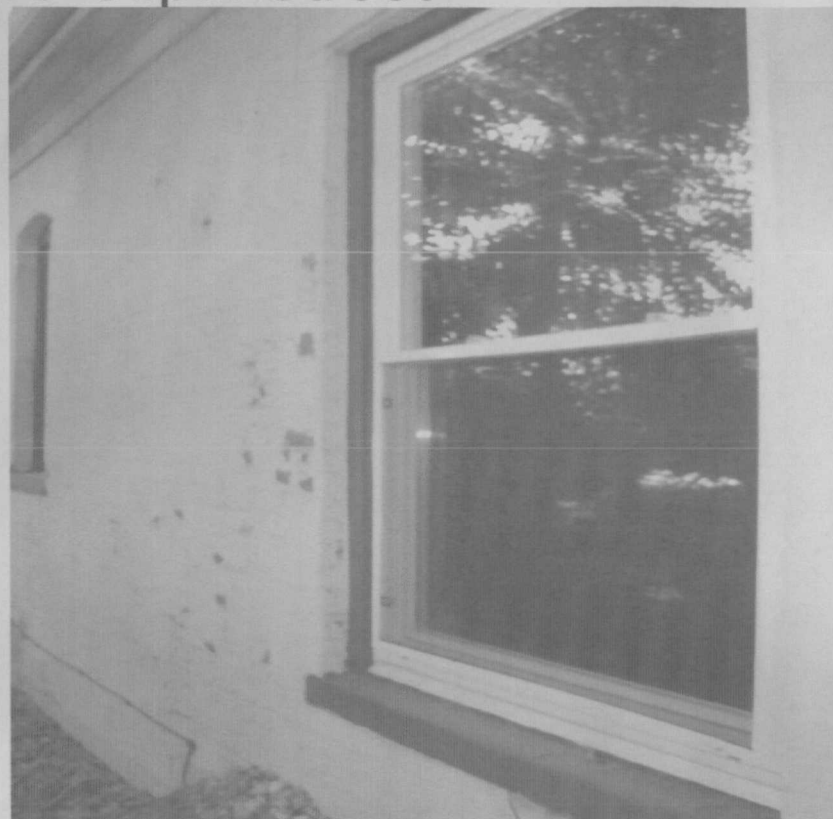
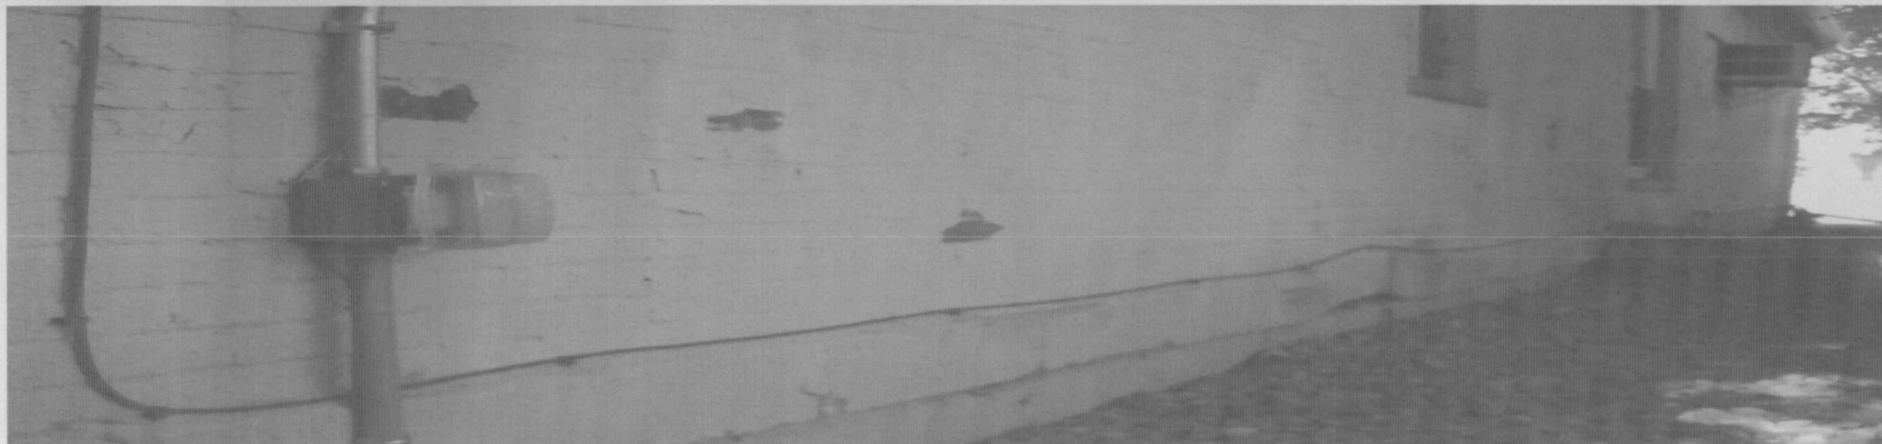
North exposure of house showing signs of peeling paint
